SATURN S-1B STAGE
FINAL STATIC TEST REPORT

STAGE S-1B-2

AUGUST 27, 1965

This report describes the acceptance test firing of the Saturn flight stage S-1B-2 conducted at the Static Test Tower East, Marshall Space Flight Center (MSFC), Huntsville, Alabama.

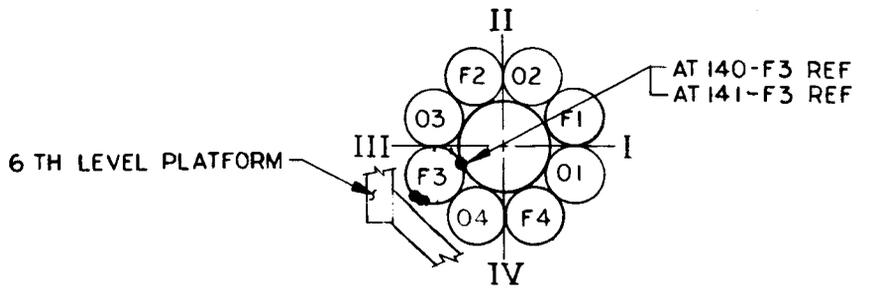
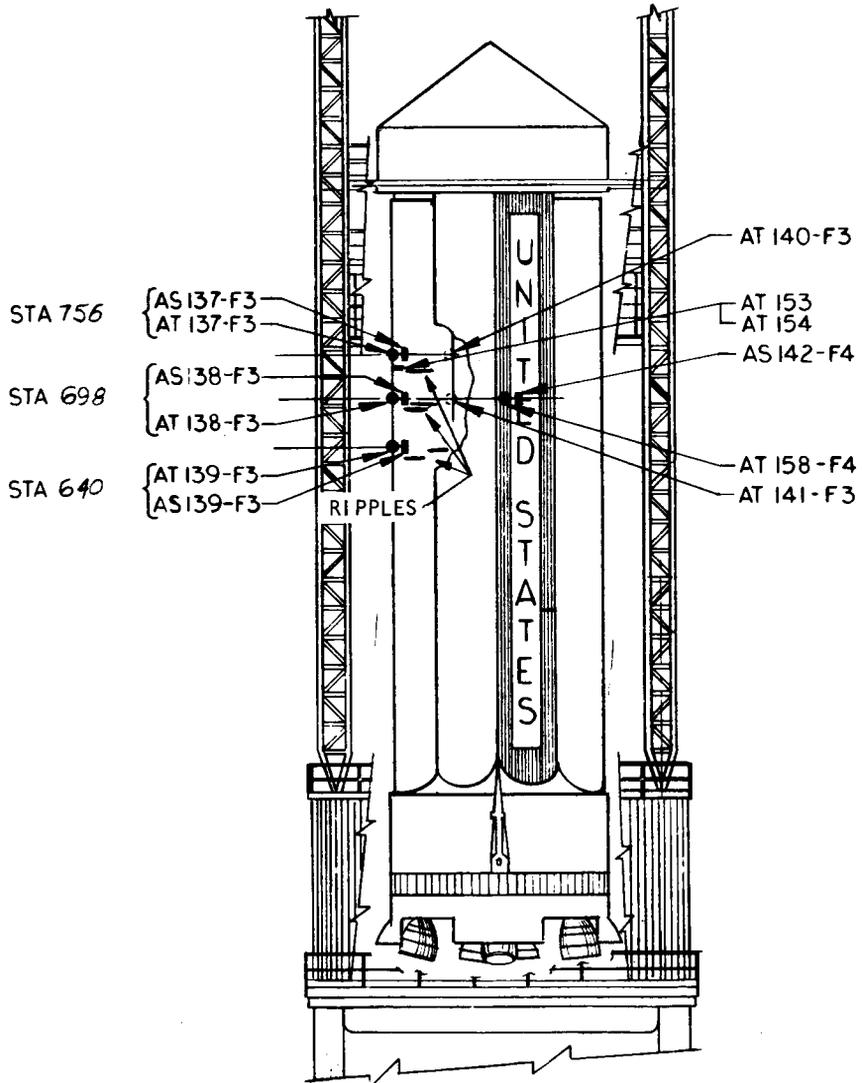
FIGURE 4-6 LOCATION OF FUEL TANK STRUCTURAL MEASUREMENTS AND FUEL TANK RIPPLES

During inspection of the booster, following test SA-29, five ripples were observed in fuel tank F-3. Similar ripples had been noted on stages S-1-10 and S-1B-1. The section of the tank in which the ripples are present is painted black and faces the flame deflector. FIGURE 4-6 shows the location of the fuel tank structural measurements and the approximate location of the ripples. The dimensions of the ripples observed after the test are listed below:

dropped, a significant difference in temperature was noted between black painted portions of the tank and the white painted areas. Thermal stresses resulting from this temperature differential exceeds the structural limits of the tank in local areas and causes the ripples to occur.

It is recommended that fuel tanks F-3 and F-4 both be painted white for static firings. This action is intended to reduce thermal stress in the tanks and to give a more uniform temperature distribution over the entire surface of the tanks. For additional information, refer to GRAPHS 4-18 through 4-22 of the "Preliminary Static Test Report, for Test SA-29".

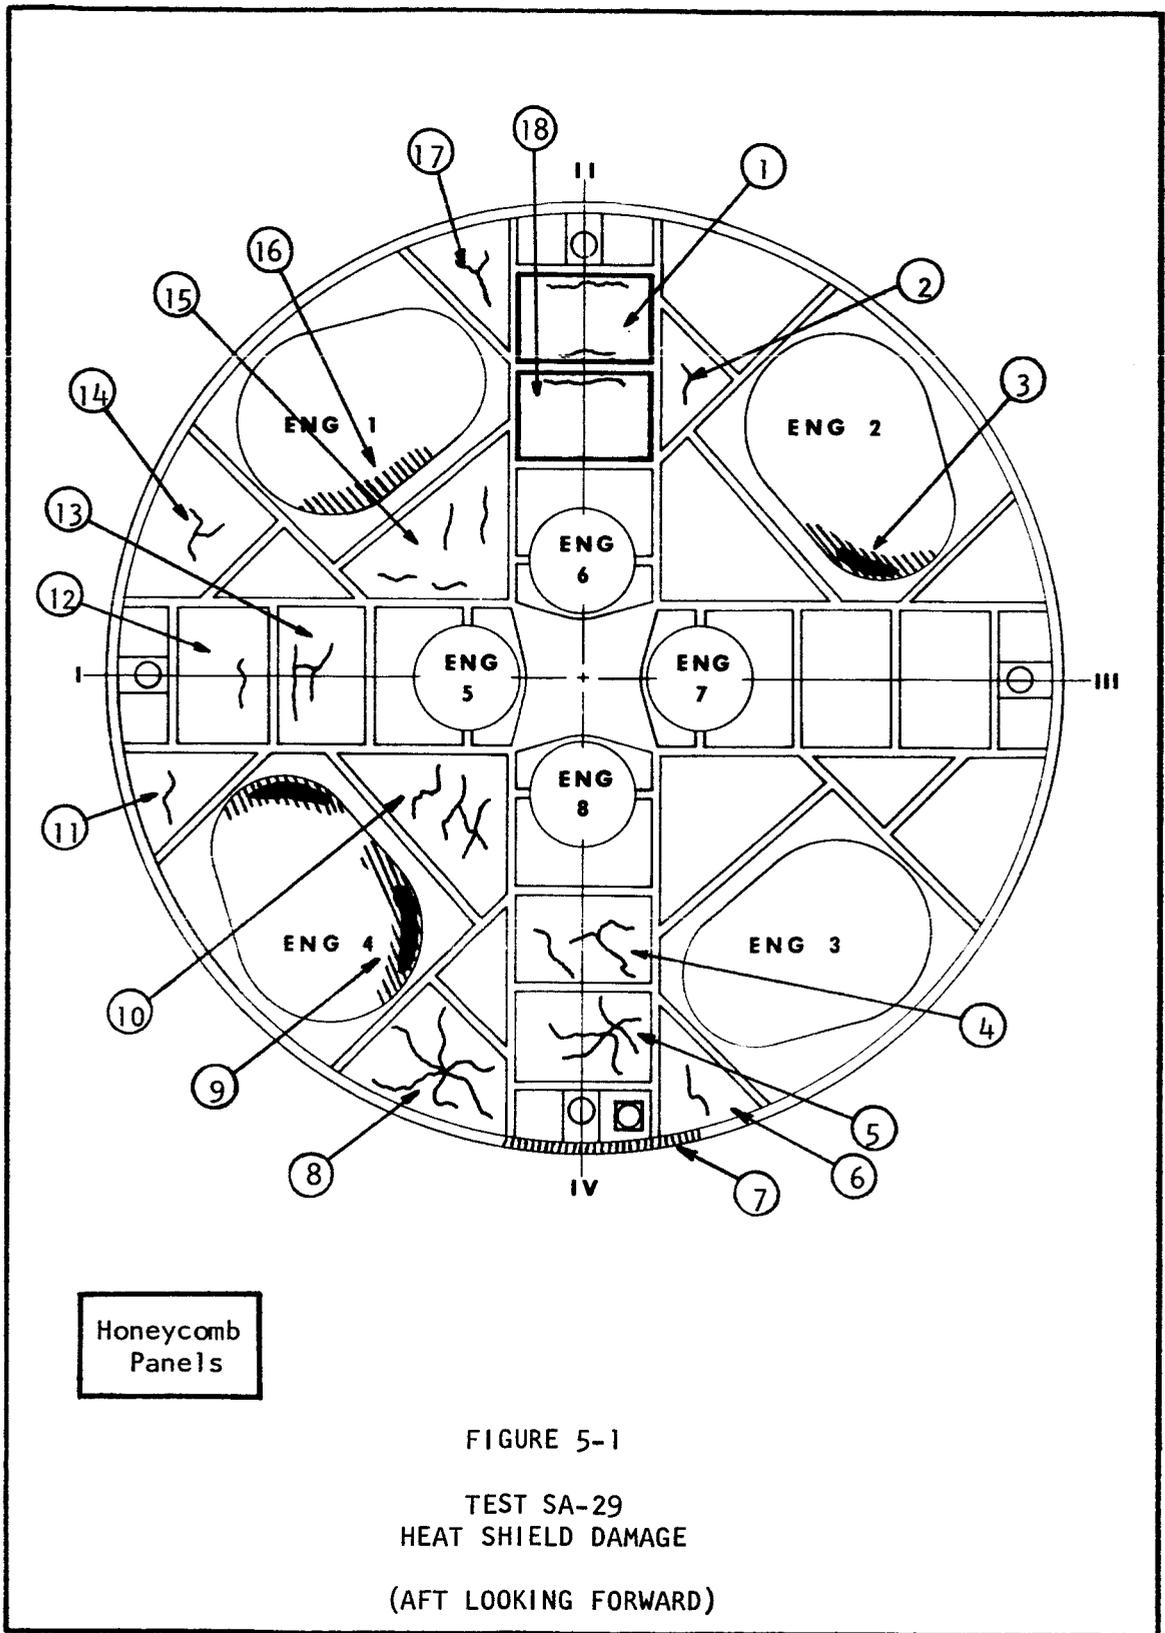
Post test inspection of the heat shield panels revealed that only slight damage was incurred during tests SA-28 and SA-29. No separation of M-31 was noted, and only minor cracking occurred. The two S-1B stainless steel honeycomb heat shield panels which were installed at Fin line 11 prior to test SA-29 were only slightly damaged. The damage that was observed consisted of numerous cracks. No separation of M-31 insulating material from the stage panels occurred. The panels were discolored, and large amounts of M-31C were burned away. The post test status of the heat shield panels following test SA-29 is shown in FIGURE 5-1 and TABLE 5-1.

REFERENCE FIG. 5-1	EXTENT OF DAMAGE
1	45 linear inches of cracked M-31.
2	15 linear inches of cracked M-31.
3	Tattered reflective heat shield curtain. Gimbal boot charred. (Approximately 30 square inches.)
4	30 linear inches of cracked M-31.
5	90 linear inches of cracked M-31.
6	20 linear inches of cracked M-31.
7	Tattered radiation shield curtain.
8	110 linear inches of cracked M-31.
9	Tattered reflective heat shield curtain. Gimbal boot charred badly in two places. (Approximately 50 square inches.)
10	100 linear inches of cracked M-31.
11	15 linear inches of cracked M-31.
12	15 linear inches of cracked M-31.
13	35 linear inches of cracked M-31.
14	20 linear inches of cracked M-31.
15	75 linear inches of cracked M-31.
16	Tattered reflective heat shield curtain.
17	25 linear inches of cracked M-31.
18	20 linear inches of cracked M-31.

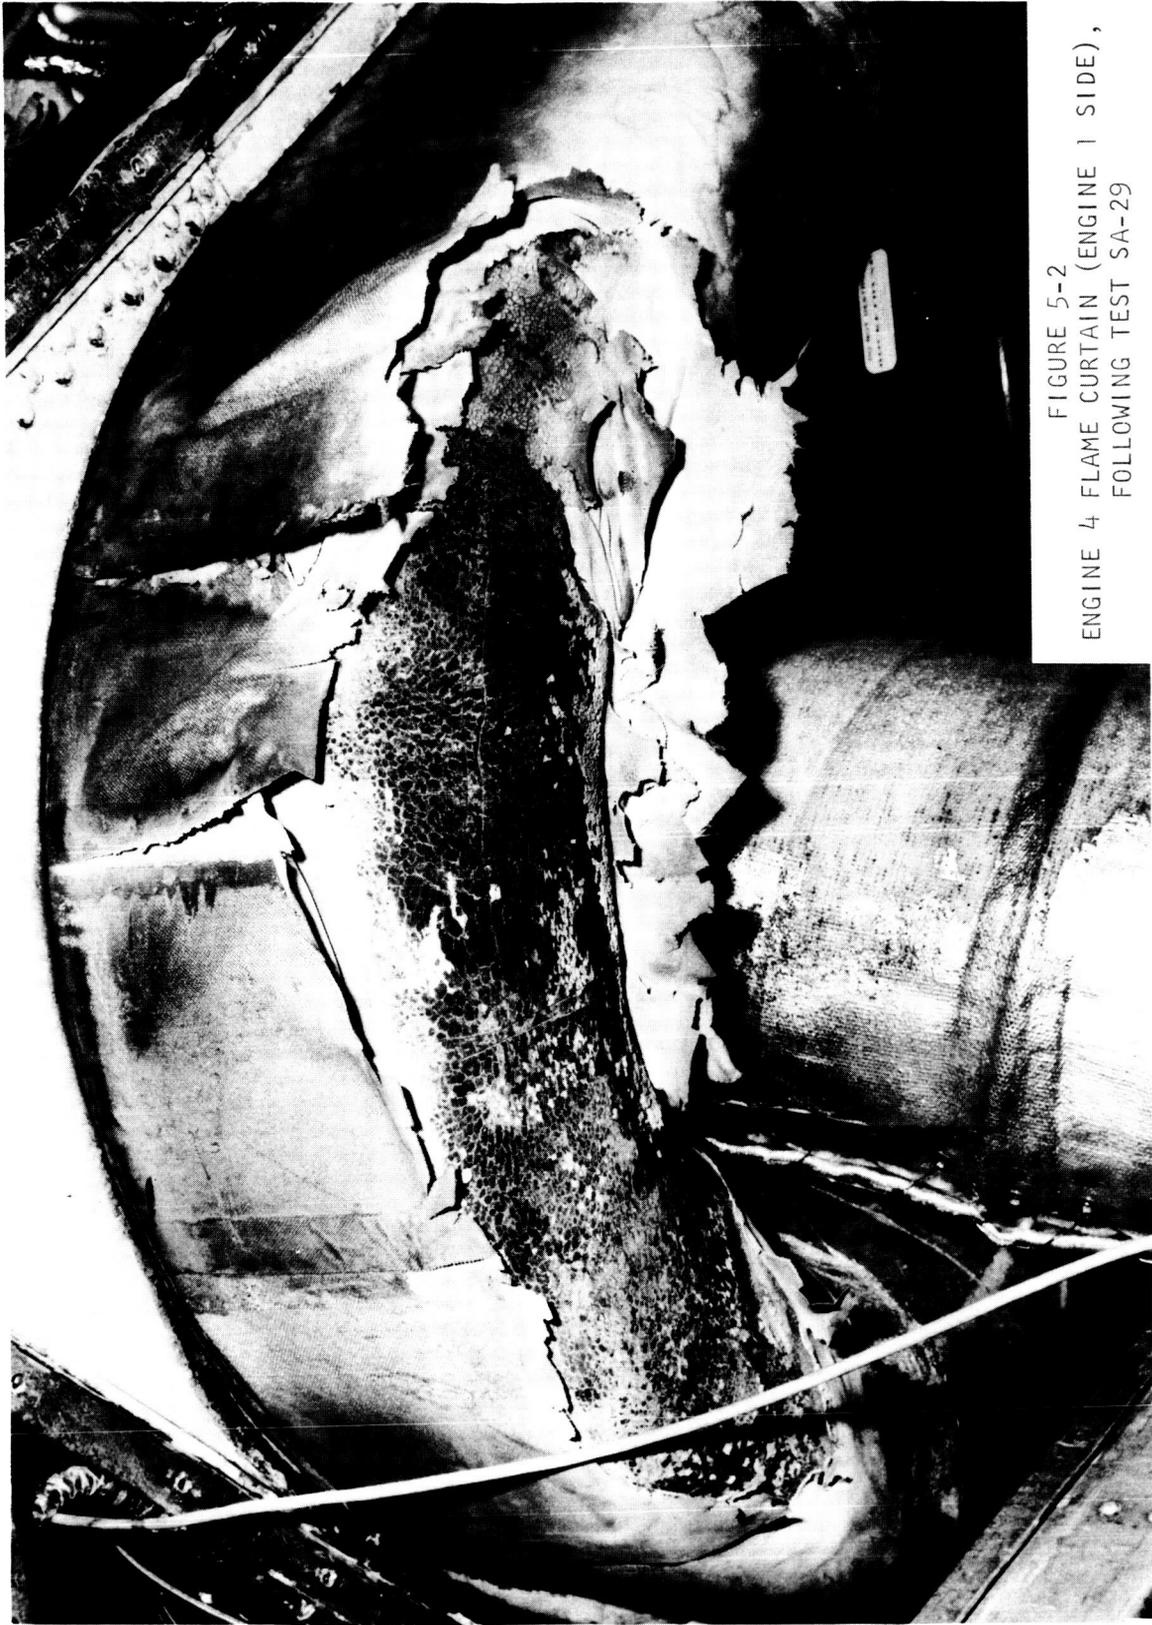
FIGURE 5-2
ENGINE 4 FLAME CURTAIN (ENGINE 1 SIDE),
FOLLOWING TEST SA-29

Inspection following test SA-29 revealed that the inboard sides of the flame curtains at engines 1, 2, and 4 were damaged. Two large holes were burned through the reflective material at engine 4, allowing the boot to become severely burned (see FIGURE 5-2). One large hole was burned through the reflective material at engine 2, allowing the boot to become severely burned (see FIGURE 5-3). The reflective material at engine 1 was burned to the extent that it became dry and brittle (see FIGURE 5-4). The flame curtains at engines 2 and 4 were observed to burn for approximately 5 minutes following cutoff. The flame curtain at engine 3 received little or no damage during this test. Normally this curtain receives the most damage.

There has been no evidence of gimbal boot charring on previous short duration firings, nor has such extensive damage been noted during previous long duration firings. It is concluded that the aluminized fabric flame curtains used during static test of S-IB-2 are unsatisfactory. It is recommended that the previously used 10C11462 flame curtains be employed on all future stages.
